SON MOIX STADIUM

PROJECT DESCRIPTION

This project is part of the first phase of the renovation works at the Visit Mallorca Estadi, which included the refurbishment and construction of the new Sol Stand, incorporating a roof of around $6.000m^2$ to shelter 6.500 spectators while offering a spectacular panoramic view of the pitch.

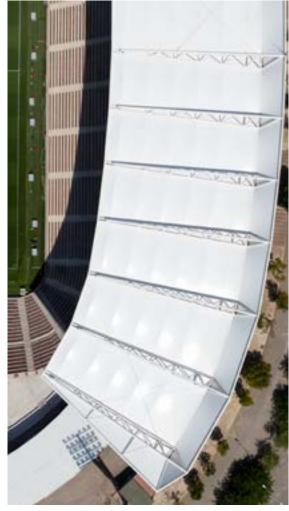
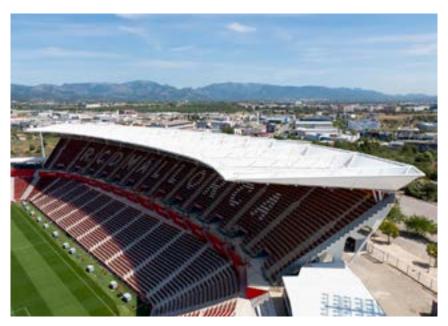
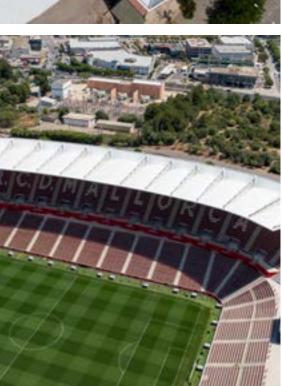
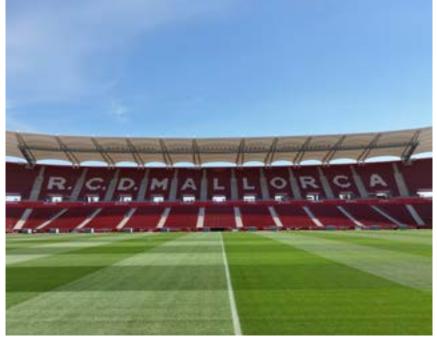
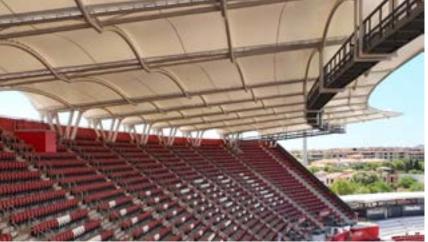
The canopy has overall dimensions of $48 \times 190 \text{m}$ and is made up of 14 trusses, each 34m long, forming 13 bays with 6 arches each. This steel structure serves as the base for the textile roof, which consists of 43 independent tensioned membranes of different dimensions, distributed into 13 membranes over the arches, 28 membranes under the trusses, and 2 lateral membranes.

The textile roof is made with polyester fabric coated with PVC on both sides (Atlas art. 760 type IV - TFL, by Sattler) and consists of 43 independent tensioned membranes of different dimensions, distributed into 13 membranes over the arches, 28 membranes under the trusses, and 2 lateral membranes.

Each membrane is manufactured in a single piece and is fixed along its perimeter to the metal substructure using

aluminium profiles lacquered in white RAL 9010 and stainless steel straps.

In the large canvases between trusses, the membrane is also fixed to the arches using aluminium profiles lacquered in white RAL 9010. These are further reinforced by galvanised steel cables anchored at their ends to the metal structure.
