BOUGANVILLA RESTAURANT CLUB

PROJECT DESCRIPTION

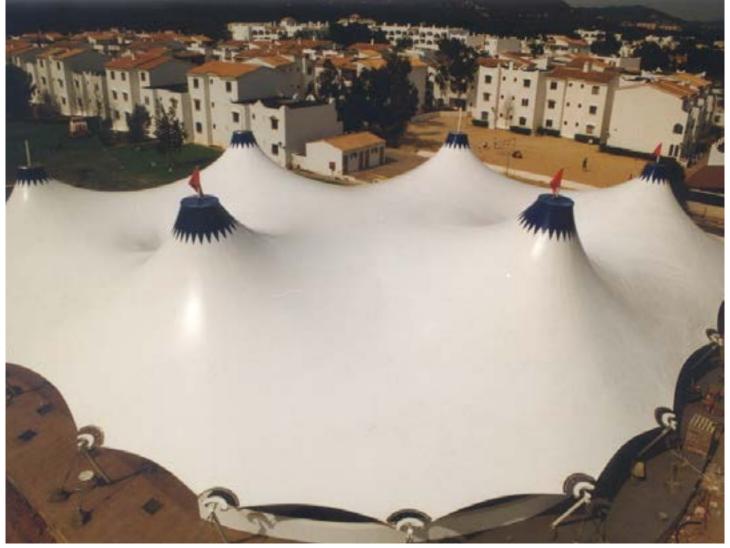
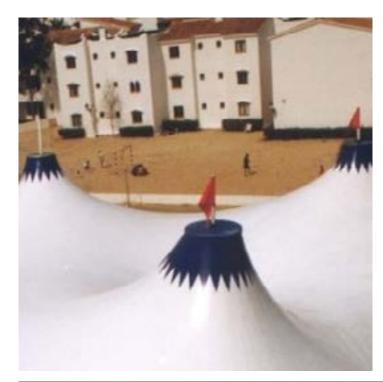
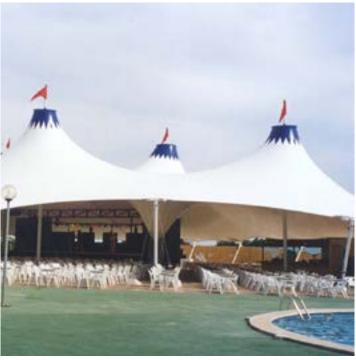
Create a comfortable and functional environment for the entertainment activities of a tourist complex. The tensile structure at the Restaurante Club Bouganvilla comprises six conoids, supported by individual pillars, and two inverted conoids that allow for rain water to escape in the center of the membrane.

Material	PES/PVC
Application	Hostelry
Surface	1.200m²
Location	Mallorca
Year	2000
